T34 World News

2012 Edition #17

CONTENTS:

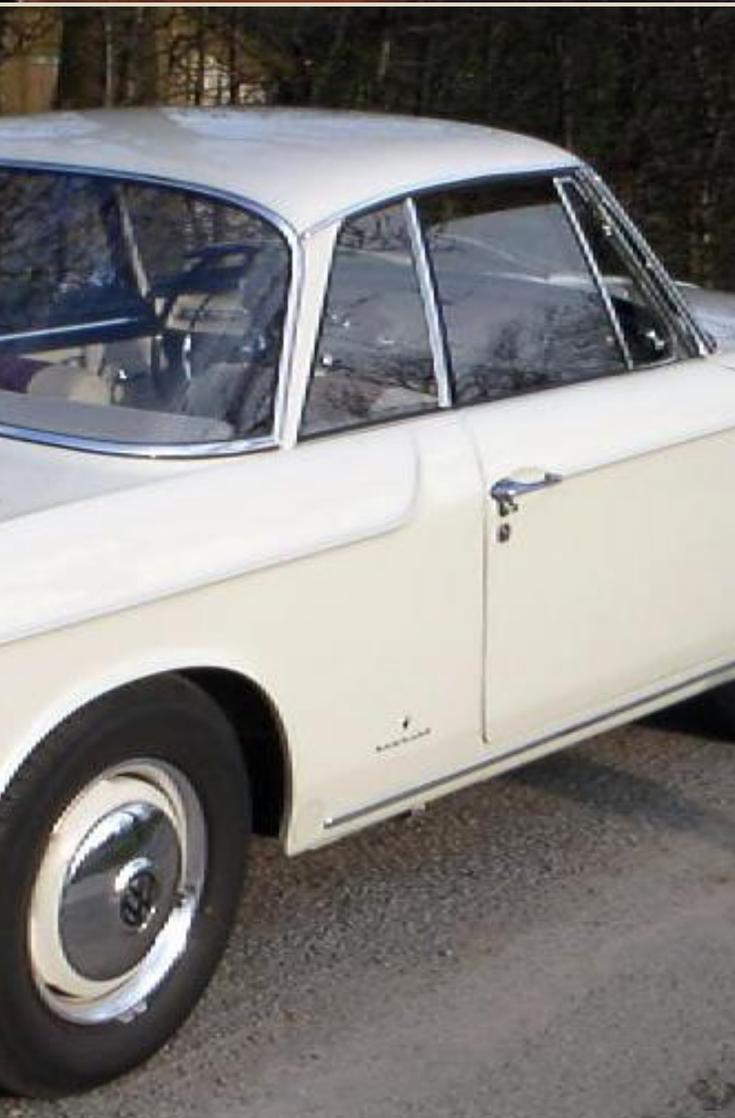
Parts Source: Karmann Script

Heiko Thum has reproduced another script that is unique to early-1962 T34s. First it was the Ghia shield and now it's the small KARMANN side script. Next will be the early-1962 nose emblem.

This KARMANN script was only fitted to the early-1962 T34s up to VIN #0 058 489 and it was fitted to the lower right fender, under the quarter window (left). The repro has the same dimensions as the original but the letters have only slightly less definition. The manufacturer found it difficult to get the sharp edges. But this is the only source for this extremely difficult to find script and the differences will not be noticed when it is installed on the T34.

The mounting posts are 1.5mm diameter. Mounting nuts are not included but you can see an original round black rubber speed-nut fits fine.

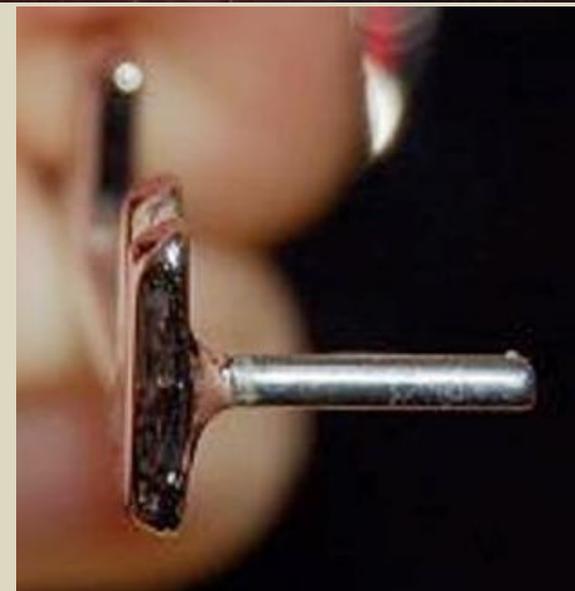
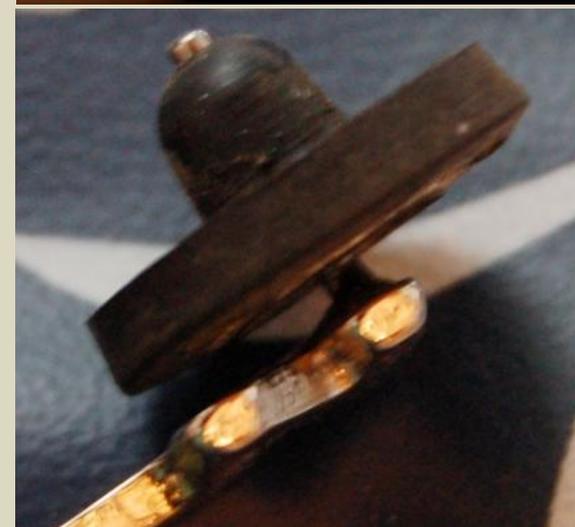
Parts Source: Rear Corner Sheetmetal Panels

Most T34s suffer from rust in the lower rear corners, a sign of a coachbuilt hand-crafted low-production car. These areas trap water & dirt easily which begins the rust process. **Jurgen Magdelyns** from Belgium [who has also reproduced the rocker panel sets & rear wheel arches] has now made the rear corner panels! These have never been available before, so if you have rust in your rear end, this is the perfect answer. Jurgen has already fitted these panels to his own projects so the fit has been tested. The angles & curves make for a complex piece of metal that is not easily fabricated by local auto body shops.

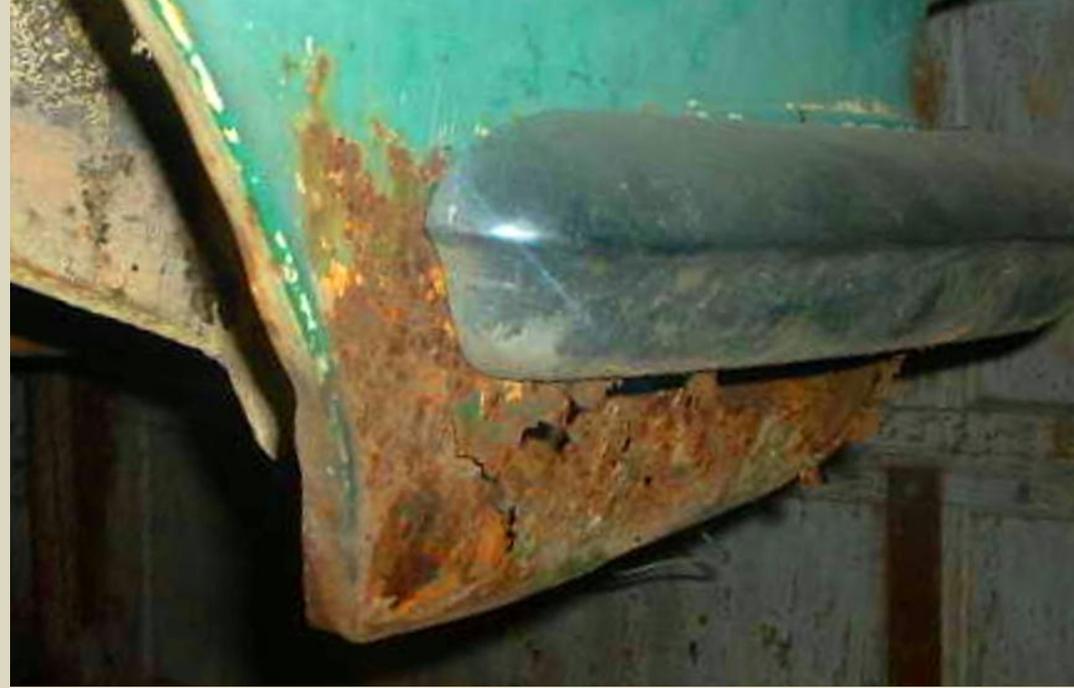
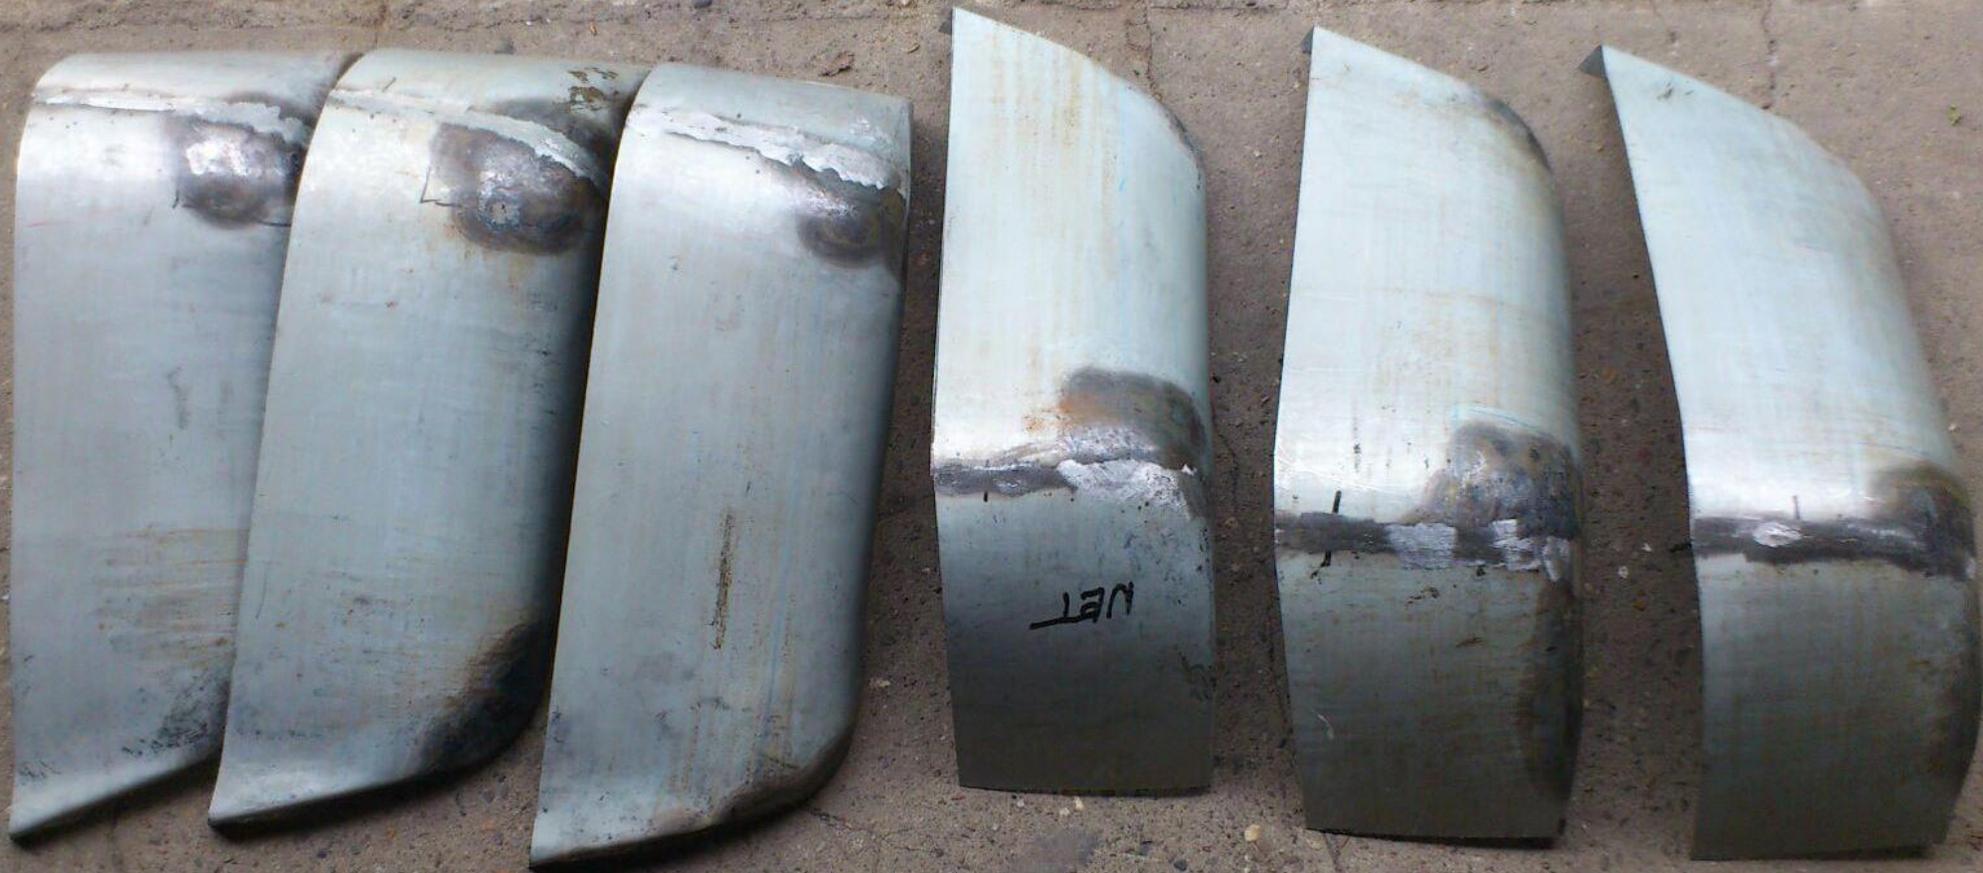
Parts Source: Hood & Door Window Buffer Plugs

The part # is 141 837 491 and you'll need 8 plugs for a T34. I'd encourage you to buy 1-2 extras in case you lose then down the hood hinge opening, which is easy to do in that tight space. Cost is US\$2 each from KGP&R (USA) or pay a lot more from other sources.

This same plug is used as an anti-vibration buffer for the door windows. It's mounted into holes on the inner edge of the window opening (pic on lower right). Two plugs help to soften any rattling noises when the door window is lowered. Installation is simple; just push the plugs into the holes. It's much easier to do when the black upper door pads have been removed.

If your front & rear hoods make a metal-on-metal noise when opening then you will need to replace the rubber buffer plugs that soften the contact. Fortunately these plugs are easy to buy since they're a T14 part and available as a reproduction. Cost for the entire car (8 plugs) is less than US\$20 shipped.

The installation can be a bit tricky the first attempt but usually takes 5-10 minutes to do both hoods. First open the hood and find the holes in the hinge base. Lower the hood a bit and place a plug into the hole, holding it with your fingers, then lower the hood down onto the plug and push down on the hood until the plug sets into the hole.

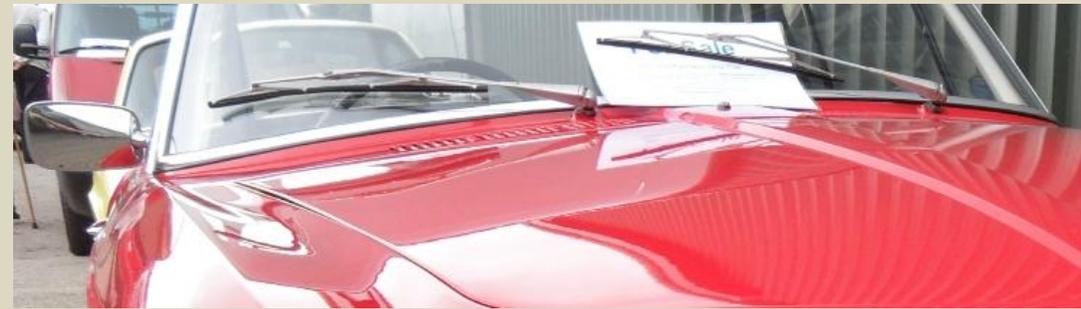
Early (1962-67) LHD wipers (above) & Late (1968-69) RHD below

Early cars (1962-67) use a 5mm spindle but for 1968-69 the spindle was enlarged to 8mm. In both cases the spindle was smooth and relied upon the wiper arm being clamped onto the spindle with a small screw. The design means that inevitably the spindle becomes scored over time and eventually there is insufficient metal left for the arm to hang onto. I have seen on some forums suggestions to weld or solder new metal onto the arm or to file down one side of the spindle to create a straight edge to which the arm might grip, but at best I suspect these are just temporary fixes.

The correct arms for the 5mm spindle are scarce for pre-1968 cars. All of those I had found were for the larger spindle. So I opted to update my car to the 8mm specification.

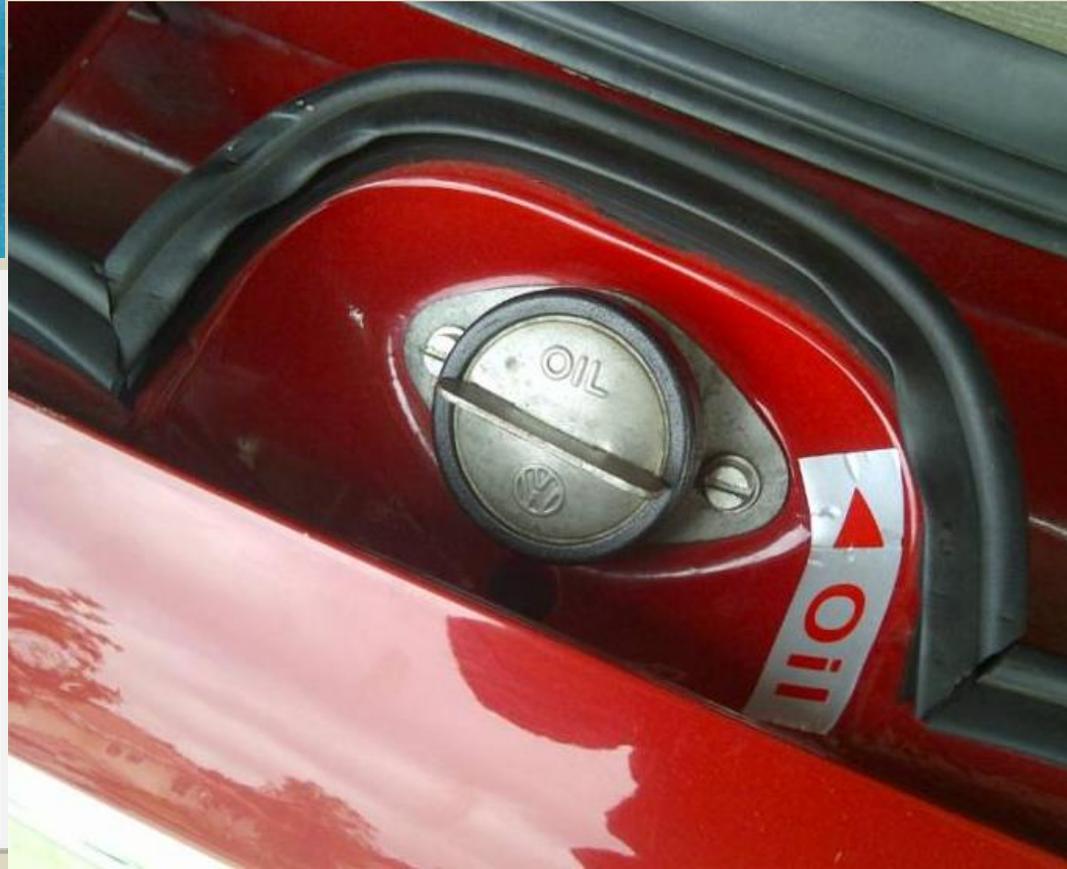
Resto Tip: Replacing Compartment Seals

The original compartment seals had several features that are important to recreate when replacing these seals with T3/T14 seals. You can see the original rear seal (above right) had joined 45 degree edges at the oil filler corners. The front seal had a cut-out area at the front edge to allow water to enter the drain tube opening (lower right). Both front & rear seals had a 0.25"/6.5mm space for the water to run down the channel easily. The long front piece was joined at the top-rear center edge. If you keep these original features in-mind when working with the T3 or T14 reproduction seals then you'll have much better results.

When you lay the front seal into position, begin at the rear-center flat edge (top right) and work the seal around before super-gluing it at the seam. Next you'll want to cut-out an area for the drain hole (top left) and install the new T14 front hood drain plug/tube (previously featured in this magazine).

The rear seal joined edges is done at the oil filler area. The joined edges need to be cut at a 45 degree angle at the corners with a sharp razor blade and then super-glued for a clean look (lower right).

The original front & rear compartment seals are no longer available and there is no T34 reproduction source for the same profiles. However, there are two seal profiles that are acceptable alternatives, one for the T3 and one for the T14. The T34 compartment seals are longer than the T3 or T14, so the standard T3/T14 seals won't be long enough to fit the T34 hoods. This page has the original seal images to visualize the details.

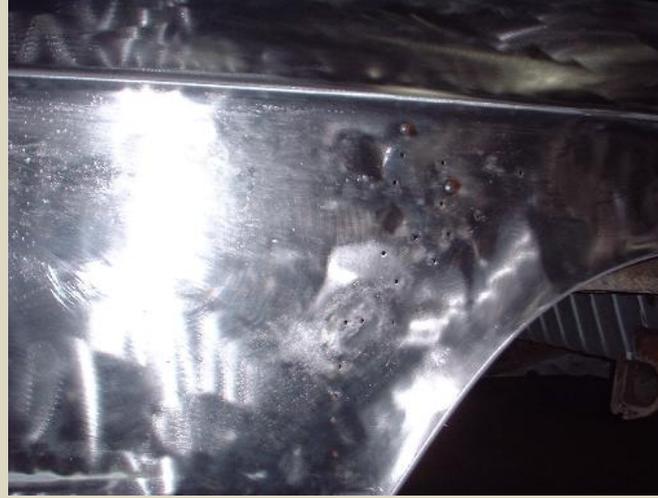
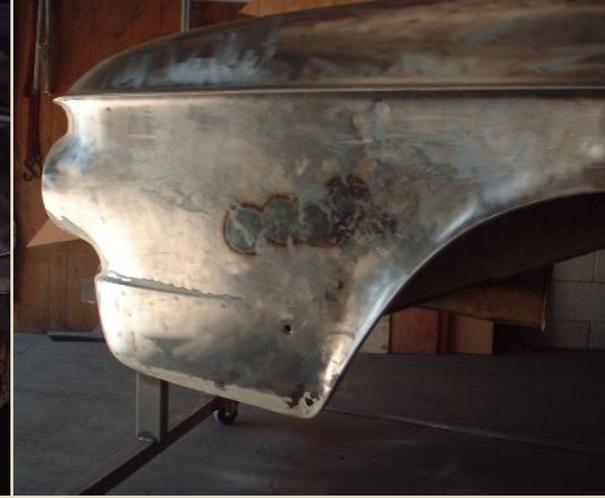
Had to change to play around trying to shrink the "oil can effect" on the rear panel (before & after pics on right) with limited success, more than anything it seems to shift the high spot more towards the rear of the car rather than getting rid of it. What did work fairly well was to mig weld a couple of blobs on the inside of the panel right in the middle of the high spot which seems to have pulled in most of it. Also brought out the swage line most of the way with a very wide chisel and hammer which has brought out the panel above and below the swage with it. It still needs a bunch more work before I'm happy to leave it be, as I don't want to just put filler back in. Nothing wrong with filler in limited amounts but I'm trying to learn how to do hammer / file work so I'll try to get it as good as I can.

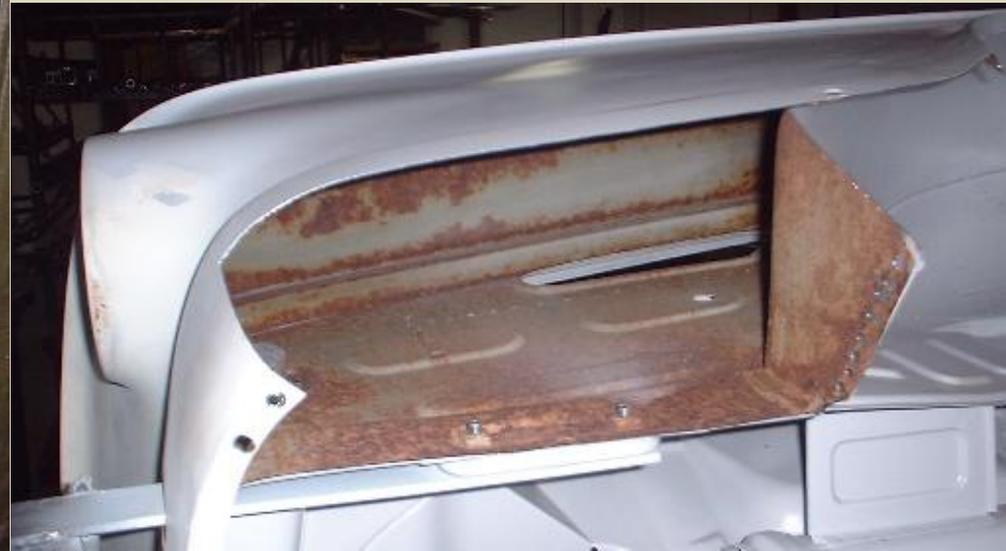
I managed some more cutting last night and opened up the rear fender (below). Most of the bottom section will be replaced with new metal as patching it isn't really a viable option. And while I have a big open hole like this I'll blast and prime the inside of the rear quarter as well.

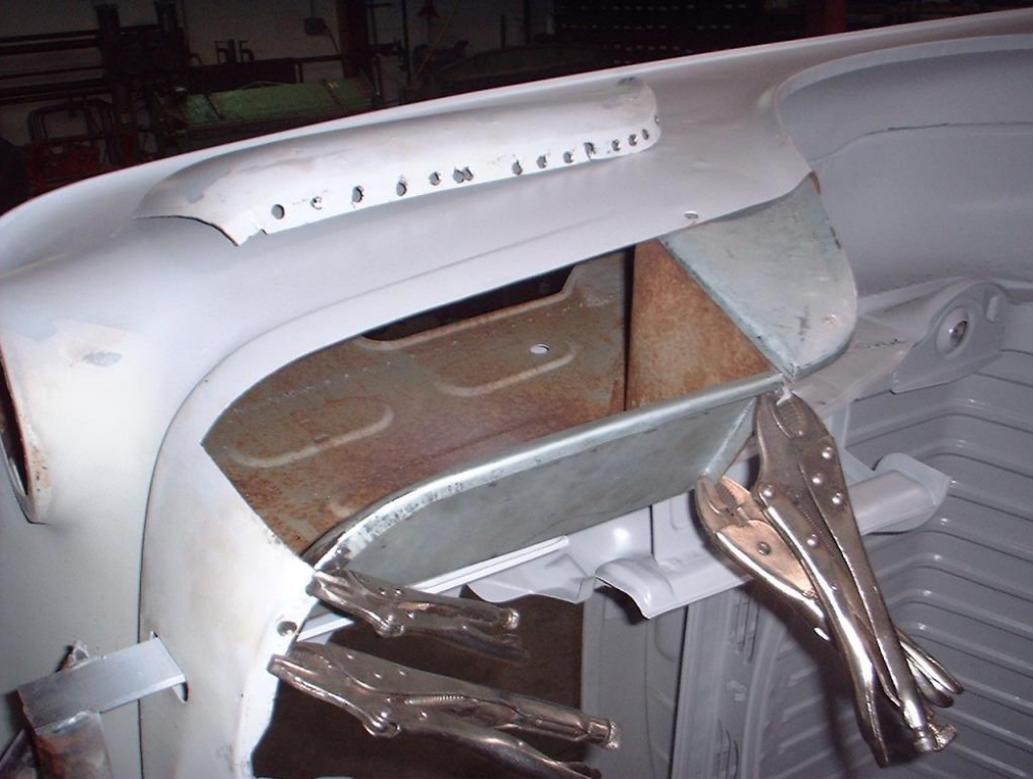
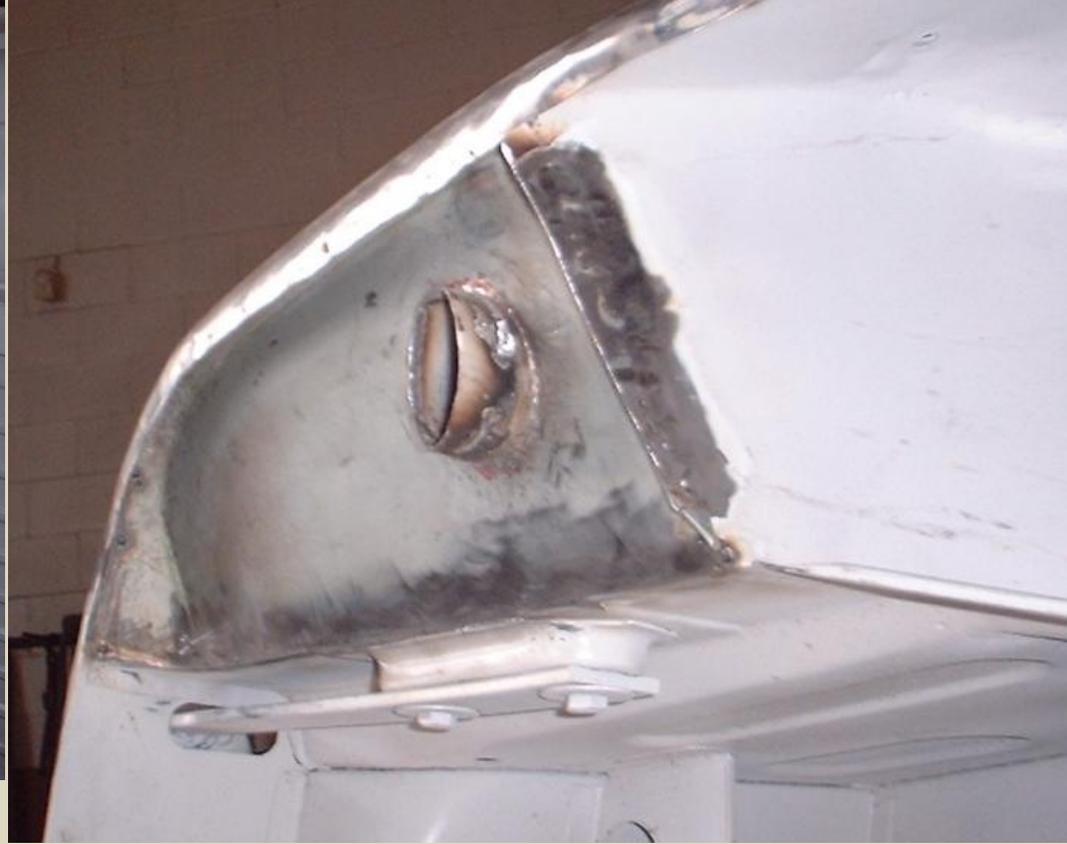
I carried on repairing the rear lower corner of the body, started with making the new section for the inner fender and it's not hard to see why these darn things rust. Perfect dirt/water trap between the two skins with no way out. I'll make a nice little drain gully in the new panels to avoid this problem in future. Next up is the lower inner panel (above) which I still need to cut a hole in for the drain pipe coming from the rear tray. A couple of these panels have some pretty complex shapes, easy enough to make in a dirty big press but by hand not so much. Struggled quite a bit with the outer skin.

The rear fender water drain pipe (top right) was a complete nightmare to get in-place so that the plastic hose would fit nicely.

The shrinking disc is a stainless disc for a grinder used to shrink metal back to its original shape. WOW, I'm amazed how well it works! In just a few hours I have the rear quarter just about finished, 95% of dents/waves gone & little to no bondo needed. I sanded the area to reveal all the lows, marked them with a magic marker and raised each low one by one with a dolly/slapstick. This process leaves high spots so then you hit those with the shrinking disc which, when rapidly cooled with water, tightens up the whole area.

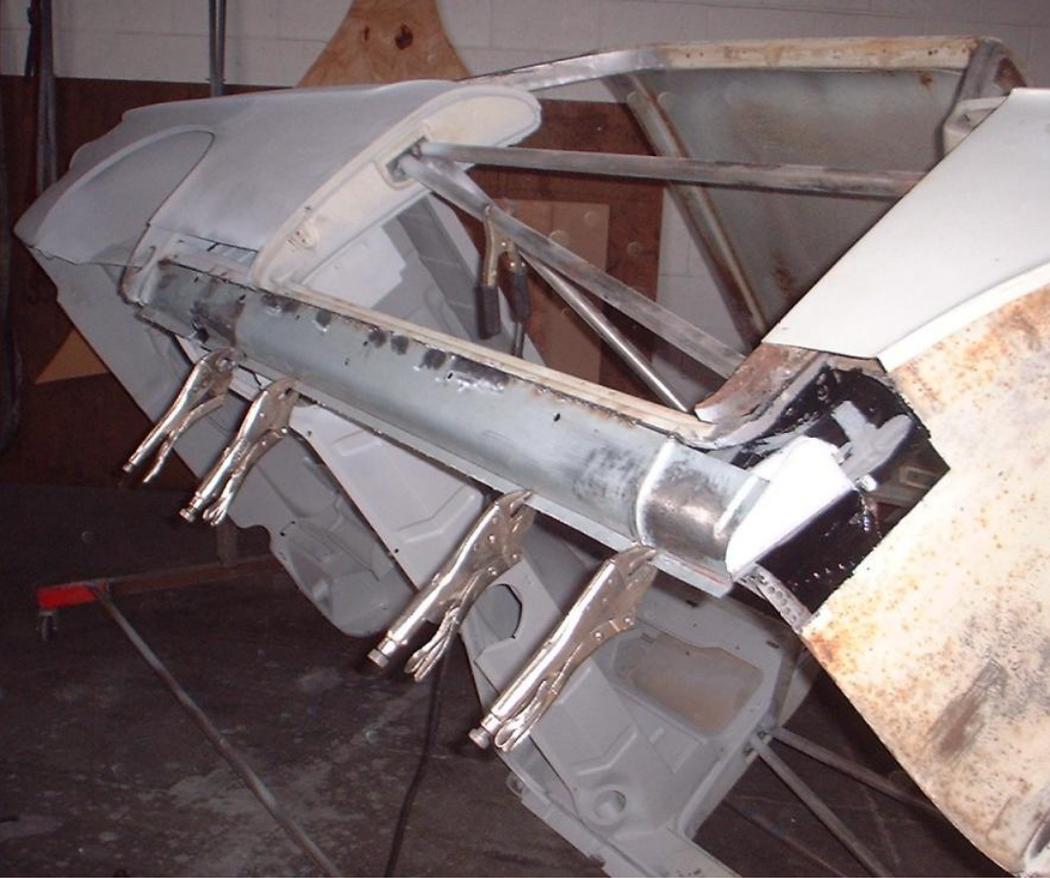
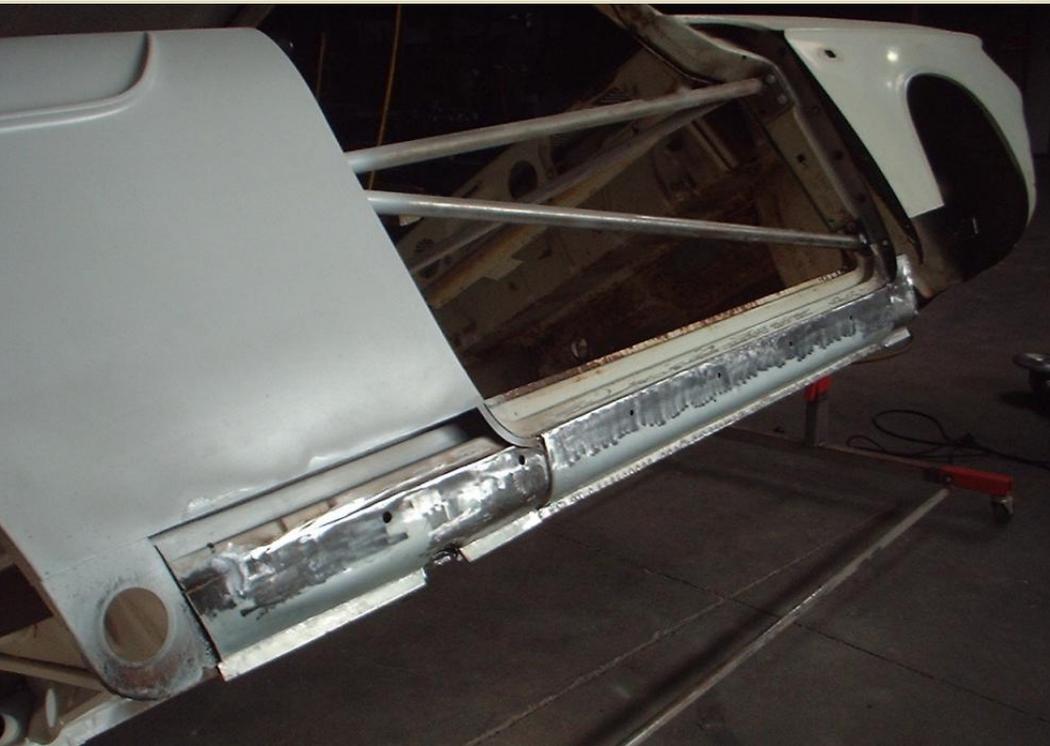
The last few nights pottering away on the car I started making the right side rocker panel (top left). After some trial and error we have a result which I'm very happy with. Made the rear section and welded it on, still some fitting/trimming to do and drill the holes for the rocker trim strip before I weld it. Making these you quickly realize what an absolute bargain Jurgen's rocker panel sets are! But for me though it's a little different as it's just time and I'm learning something in the process. Quite a big step forward again in the fight against rust, a couple of days ago I painted the inside of the heater channel with some tough chassis black and at the same time painted the inside of the new rocker panel so hopefully it should last longer than the original.

There was a big temptation to weld the whole piece in but that will bite you with severe warping due to the heat and since I can't get to the inside after wards I just took my time, the welding came out ACE! Little to no distortion so no bondo will be required here! Once the welds were ground up I moved on to capping the end of the heater channel at the A pillar. The new section fabbed up was easy to weld on. The factory has a real rust trap here with a gully of sorts at the end of the heater channel that fills up with dirt and water so I eliminated that and did it my way which is better.

Final piece for the day was the inner fender at the rear at the torsion hole (below). This area was also rusted through so a new piece was made and fit good. I will continue here next edition by cutting the torsion hole and final trimming it to size. I'll probably start looking at making the outer fender panel which will nearly complete one whole lower side of the car! YAY, very pleased!
